Modification of Test Wing to Accommodate Fuel Load Effects for Deicing Research: 2001

APS AVIATION INC.

October 2001

Final Version 1.0

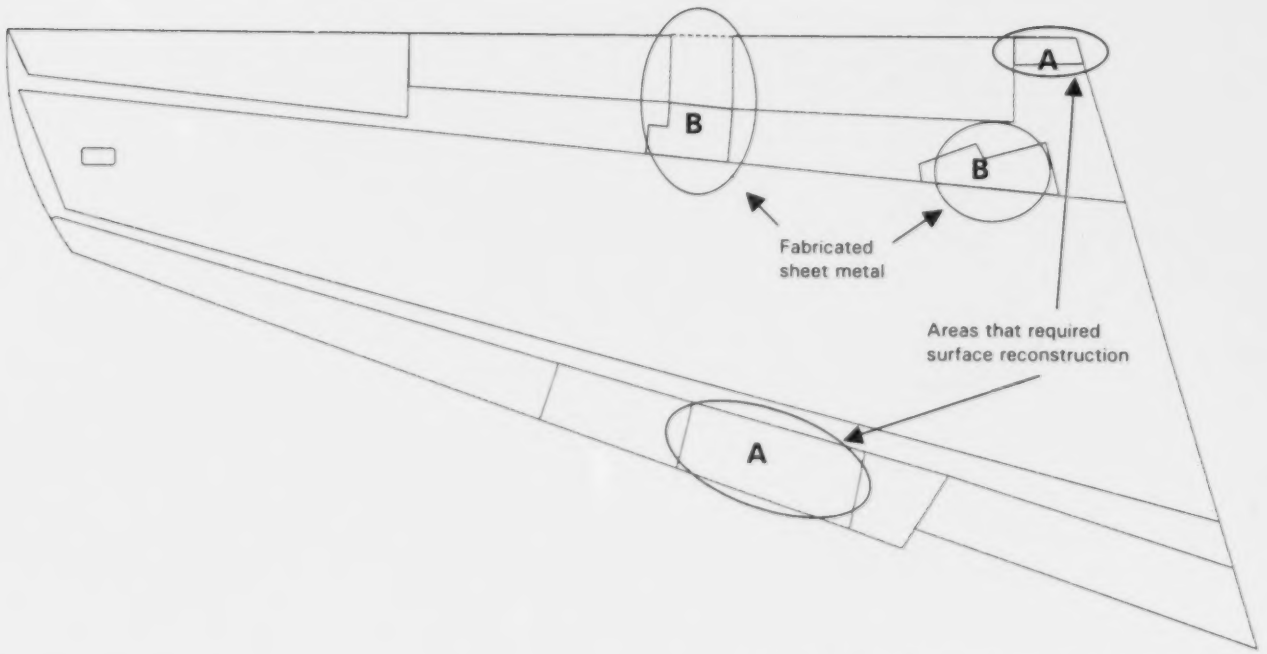
FIGURE 2.3
Sheet Metal Work

Sheet metal parts were constructed to replace several sections of the upper wing surface and the area where the external fuel tank was removed. These metal pieces were riveted into place and sealed with PRC aircraft sealant. "Ribs" were assembled under the sheet metal on the leading and trailing edge of the wing to maintain structural integrity. Other areas that required modification with sheet metal were one of the three fuel tank feeds, a cover for the fuel vent, and the actuator for the leading edge slat. The locations of the sheet work performed on the wing are shown in Figure 2.3 and Photo 2.11.

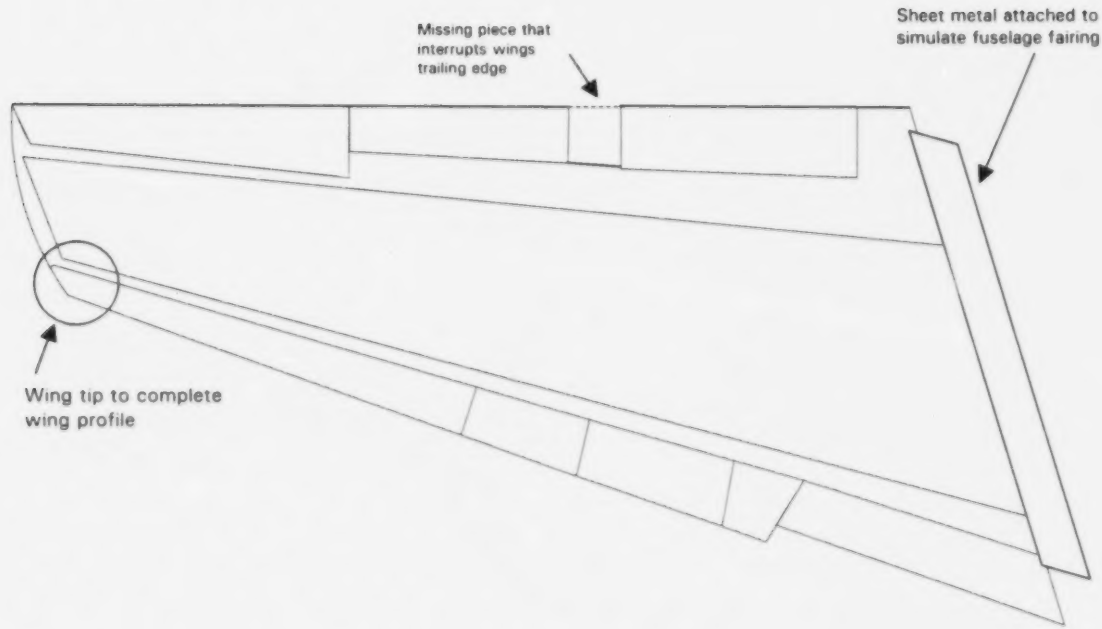
FIGURE 2.5
Wing Root and Wing Tip

The wing tip was installed; however, the leading edge of the tip was missing and was not replaced. Refer to Photo 2.11 and Figure 2.5.

Missing piece that interrupts wings trailing edge
Sheet metal attached to simulate fuselage fairing
Wing tip to complete wing profile

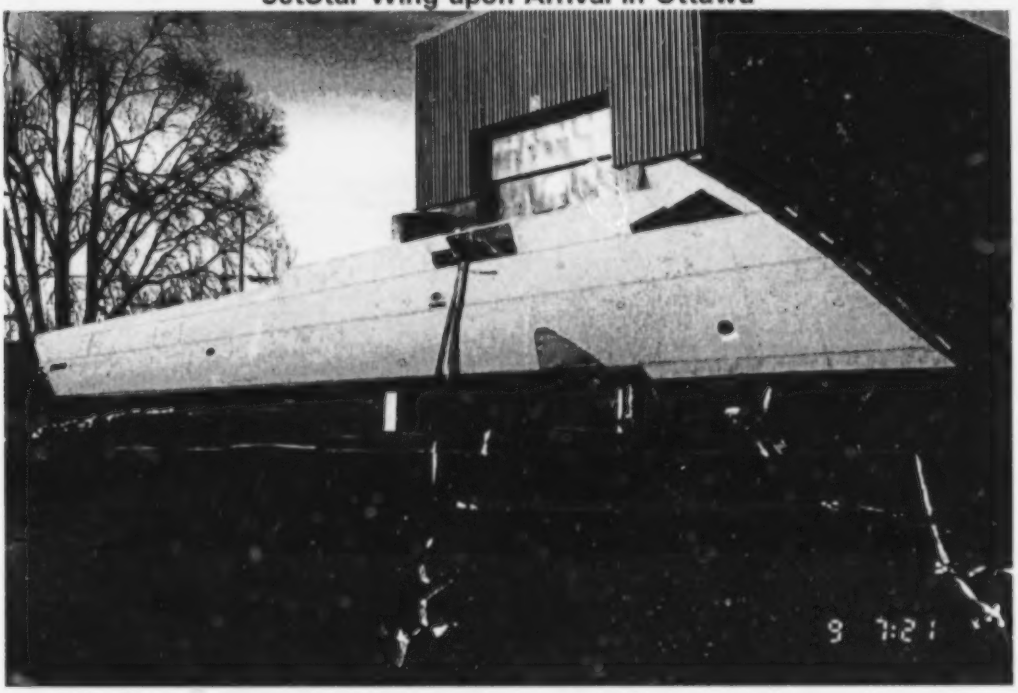
Photo 2.3
JetStar Wing upon Arrival in Ottawa

Two small panels on the main wing section were missing when the aircraft was delivered to APS in April 1999 (see Photo 2.3). The salvage company had removed the external fuel tank (see aircraft three-view drawing in Figure 2.1) prior to delivery of the wing. A fairing was fabricated to fill the large hole in the leading edge where the tank had been and to restore the original wing profile. The fairing and replacement panels were constructed from galvanized metal and then painted.

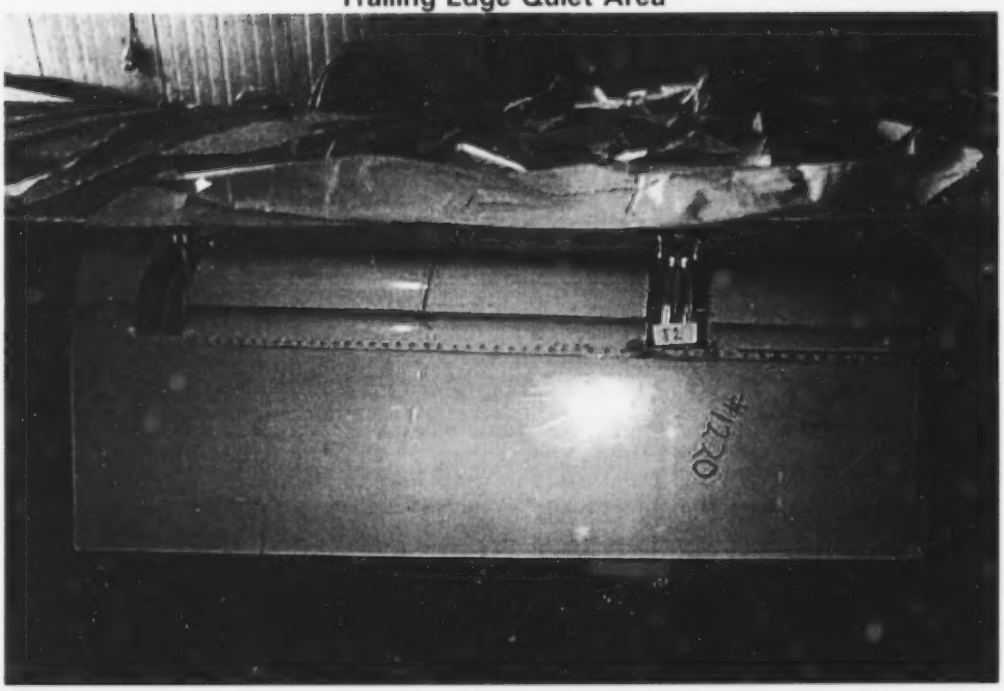
Photo 2.6
Trailing Edge Quiet Area

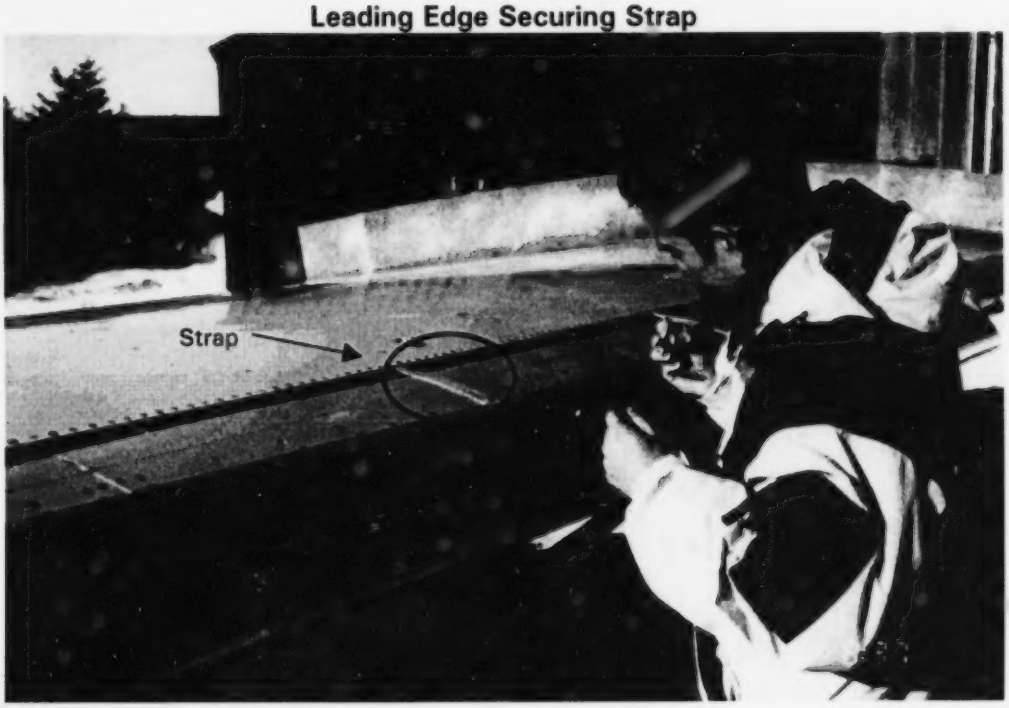
Photo 2.12
Leading Edge Securing Strap

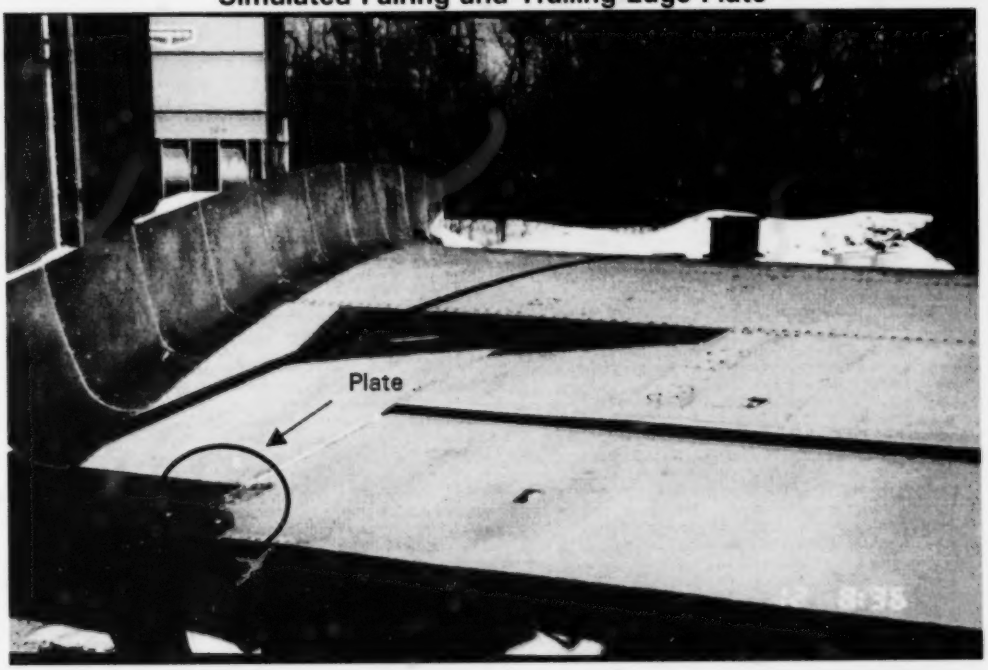
Photo 2.13
Simulated Fairing and Trailing Edge Plate
